**Re: GE-Pittsfield/Housatonic River Site  
Silver Lake Area (GECD600)  
2018 Annual Monitoring Report**

# 2018 ANNUAL MONITORING REPORT

Silver Lake Area

February 2019

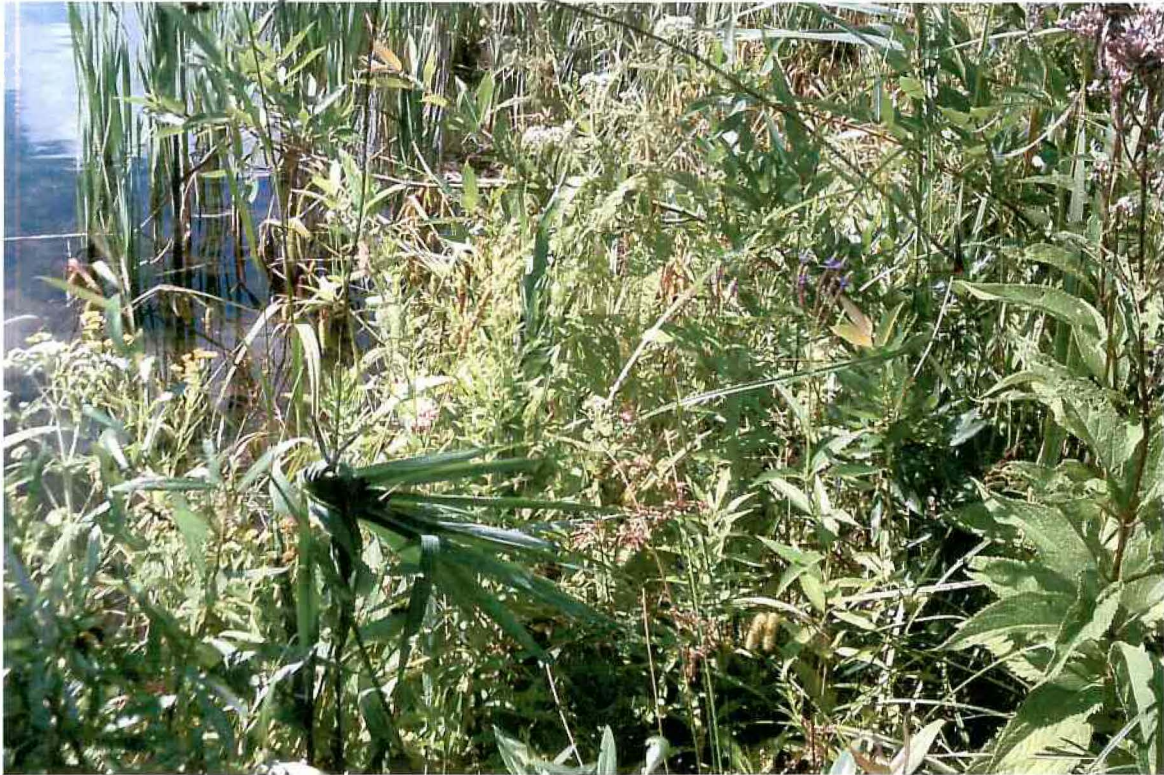
Phragmites

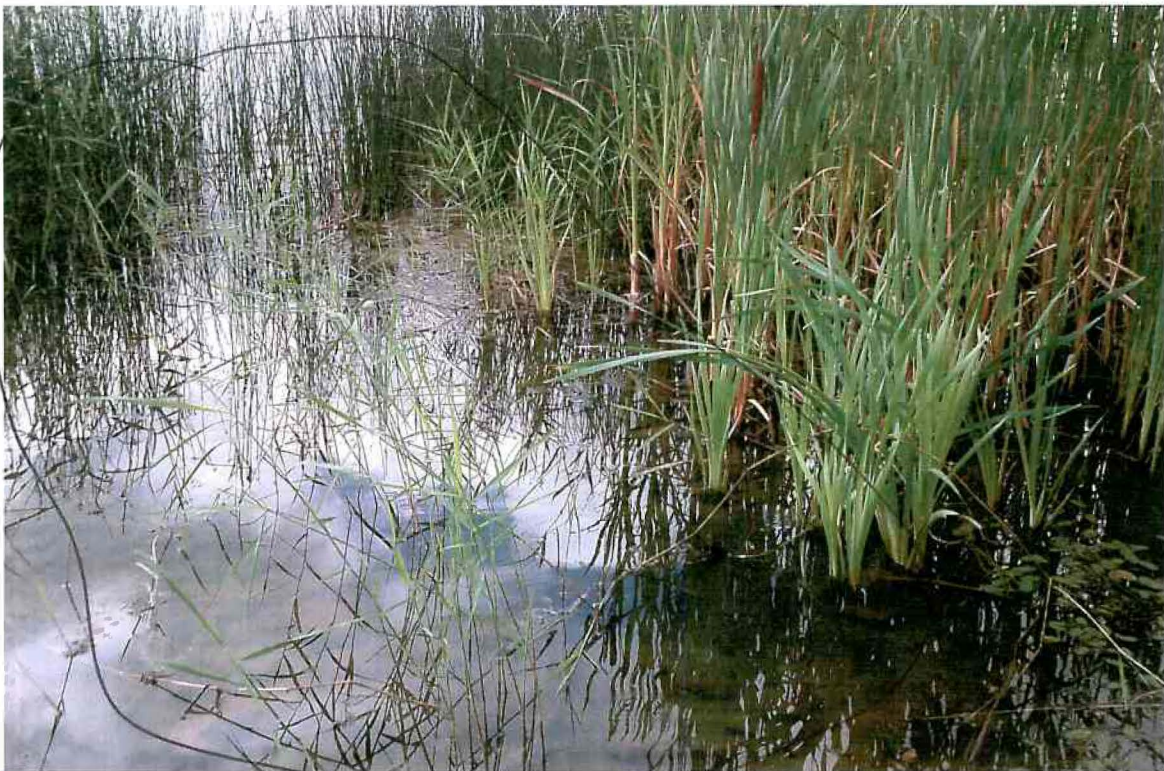
PHRAG Patch in water

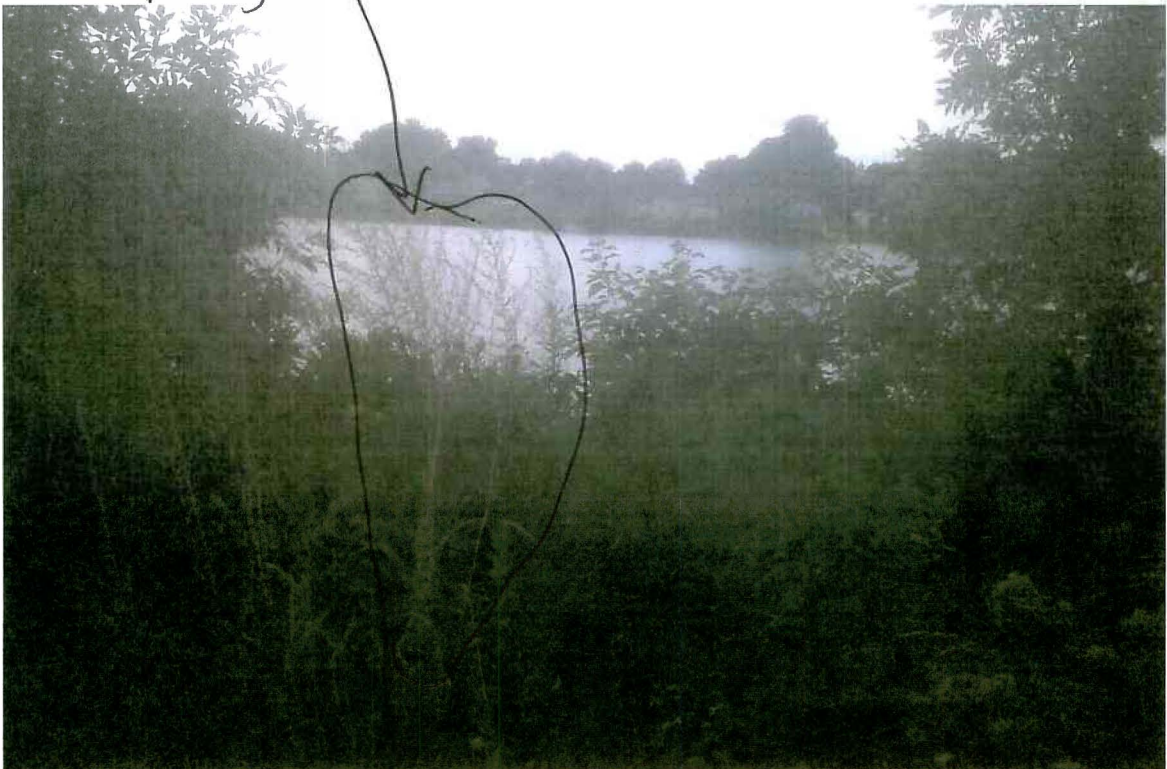
Mugwort

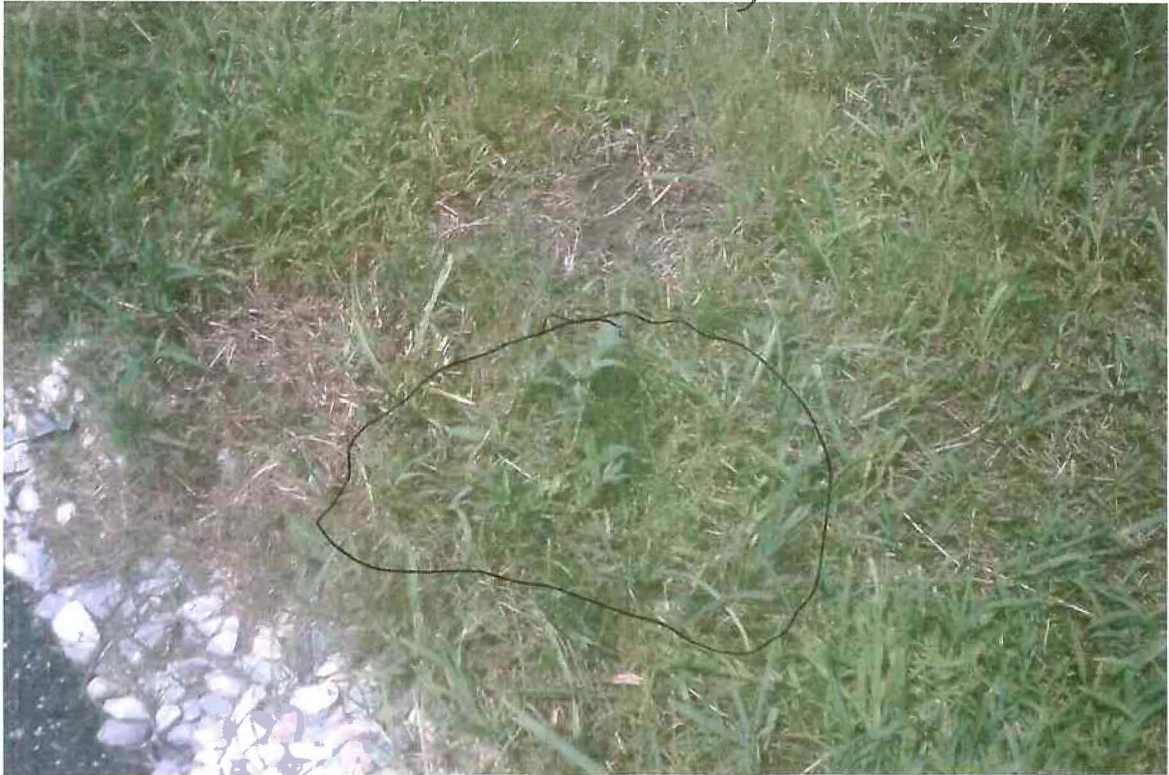
Spotted Knapweed Seedlings

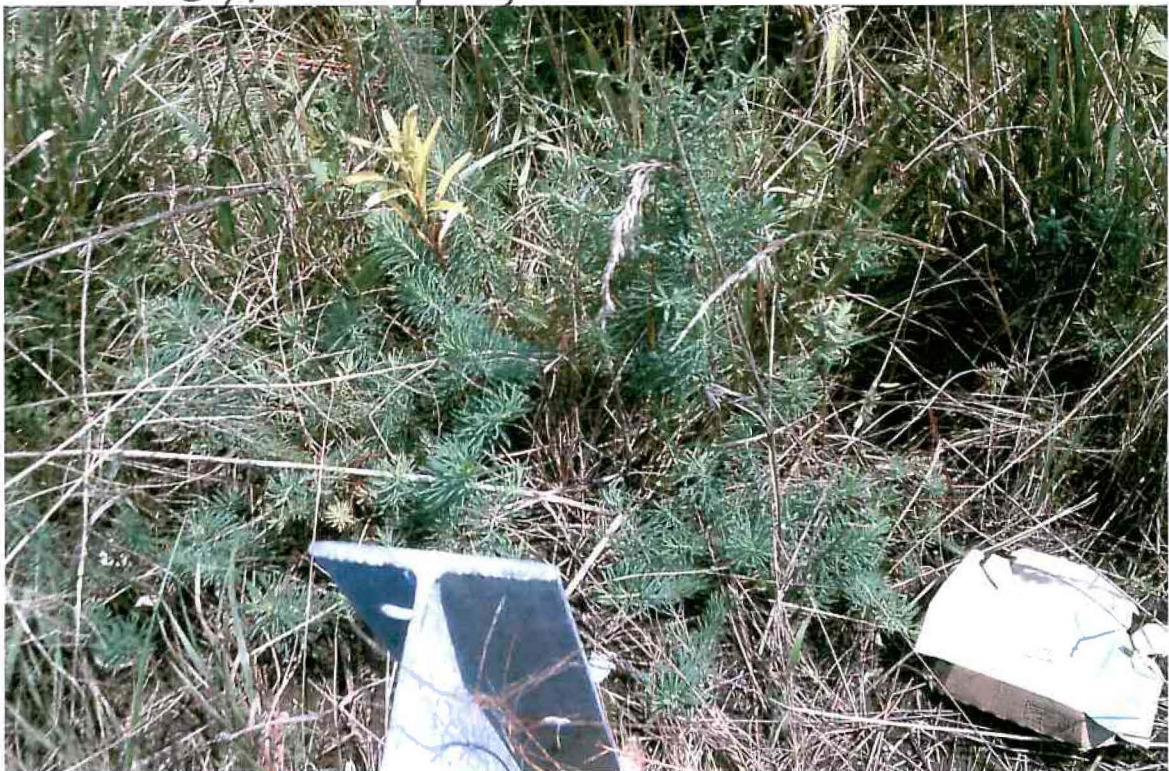
Cypress Spurge

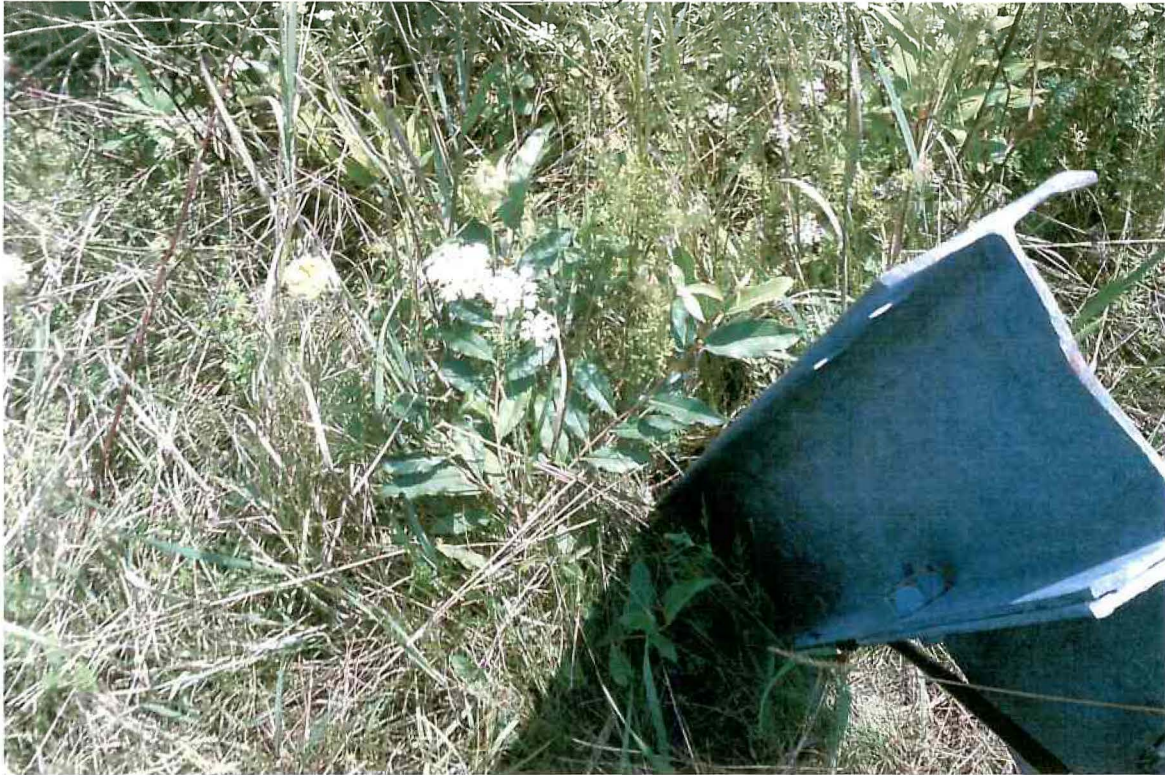
Mugwort Seedling

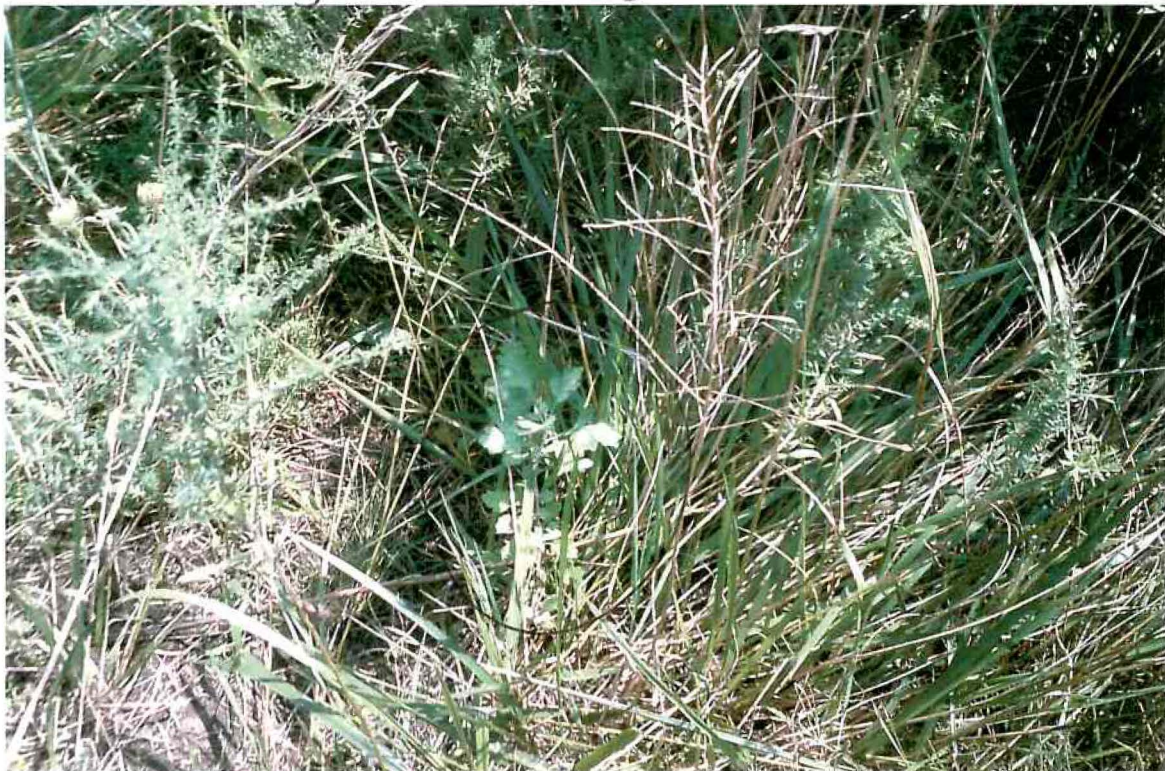
Mugwort + Spotted Knapweed

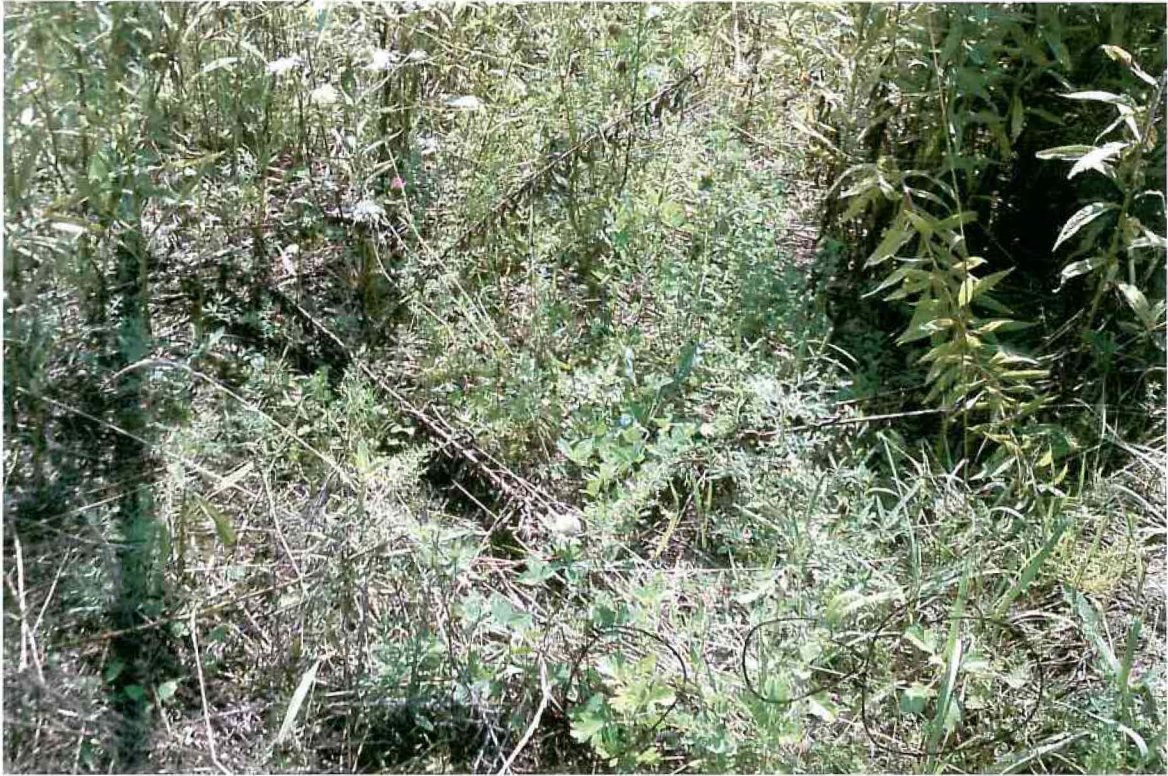
Mugwort Patch (SW)

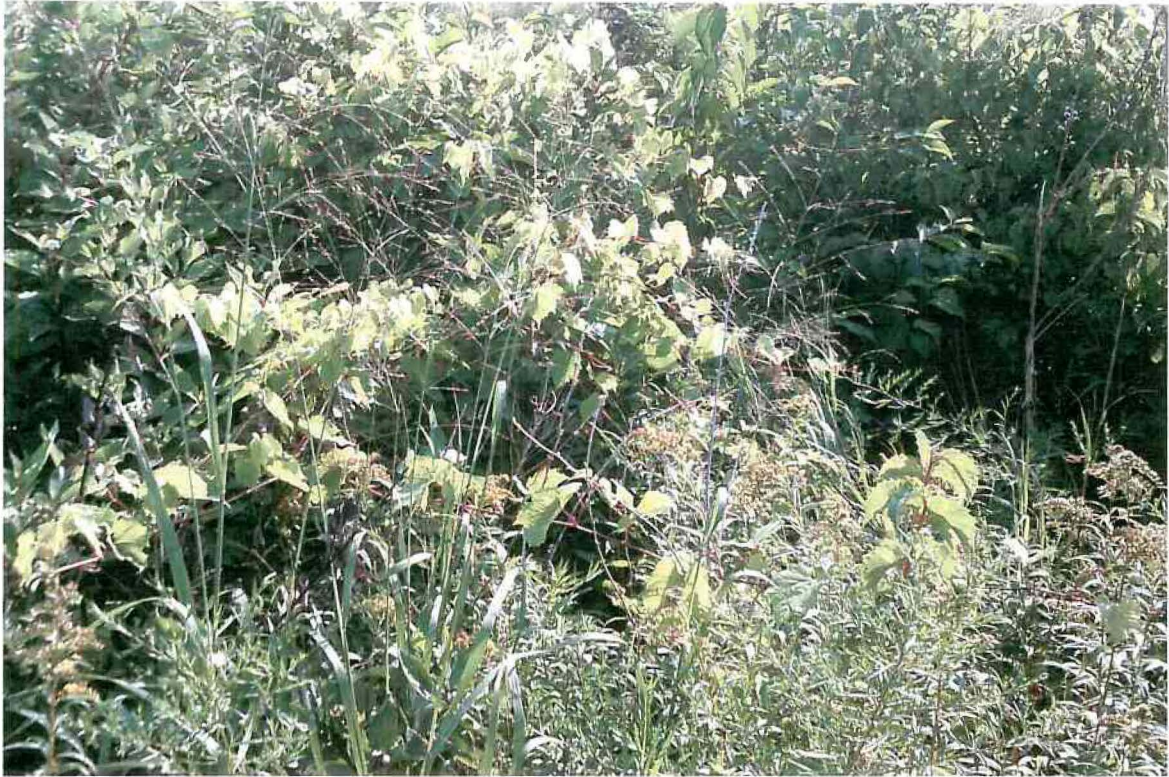
Mugwort Seedlings

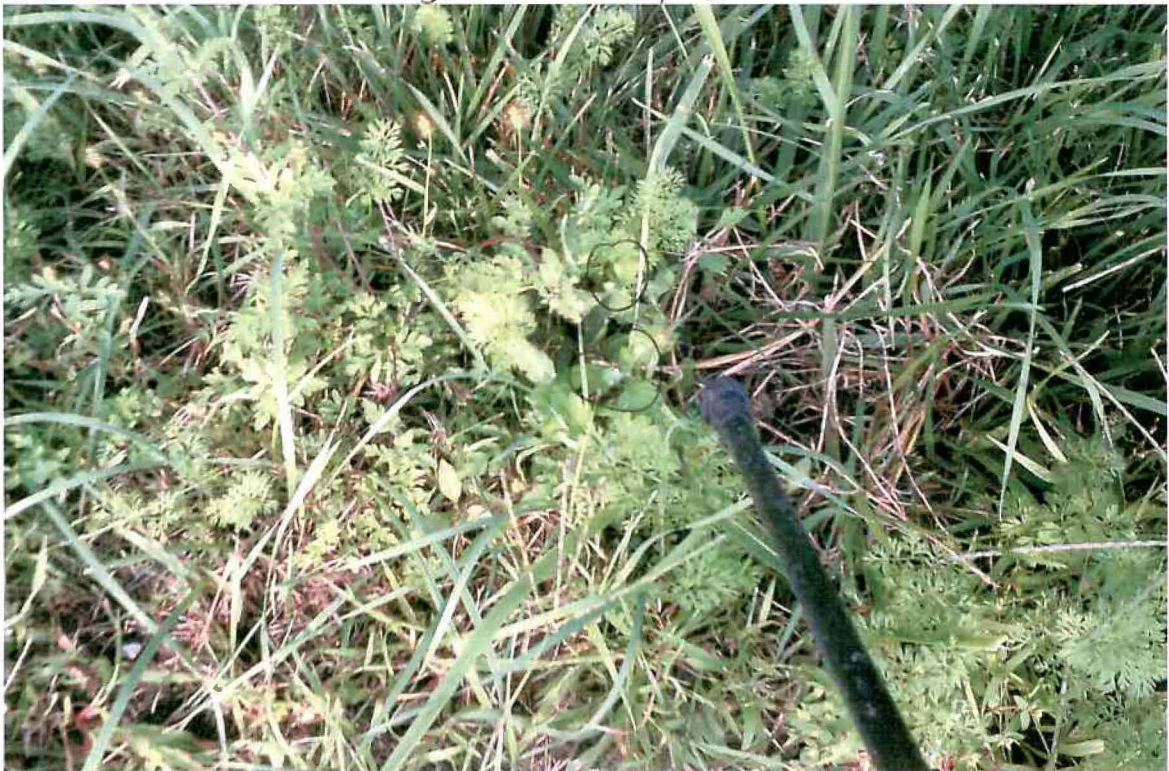
Spotted Knapweed

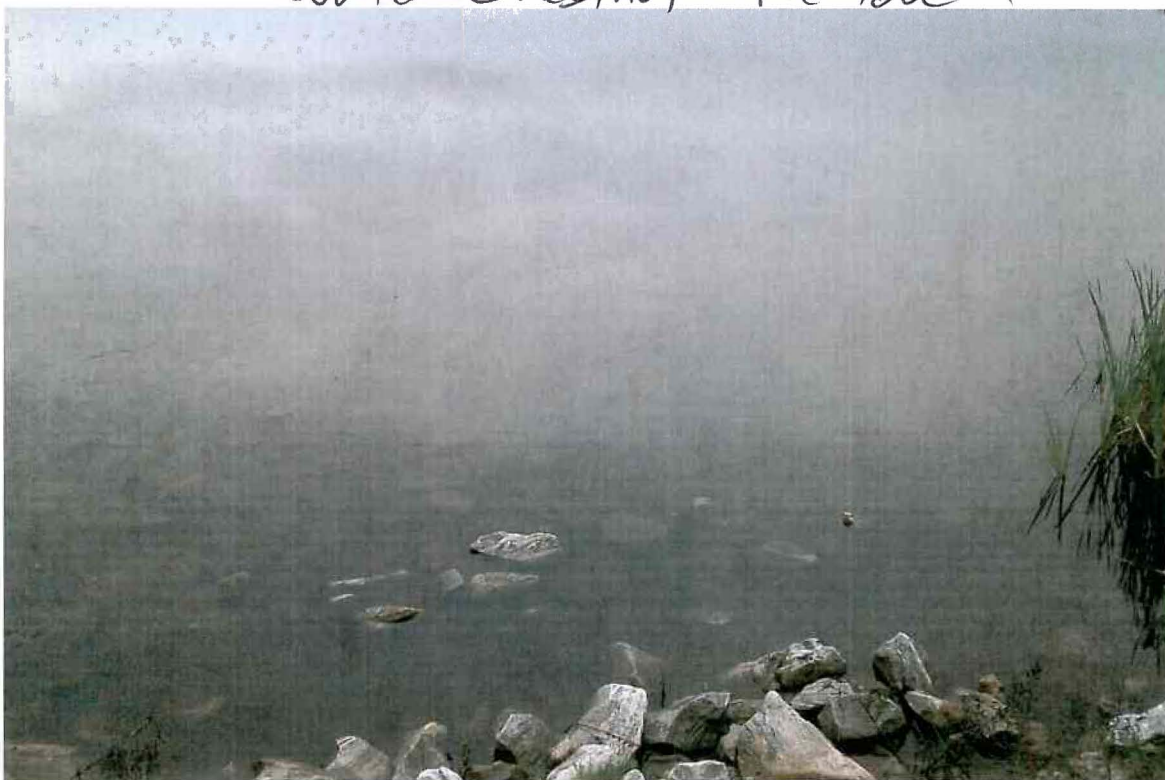
Water chestnut

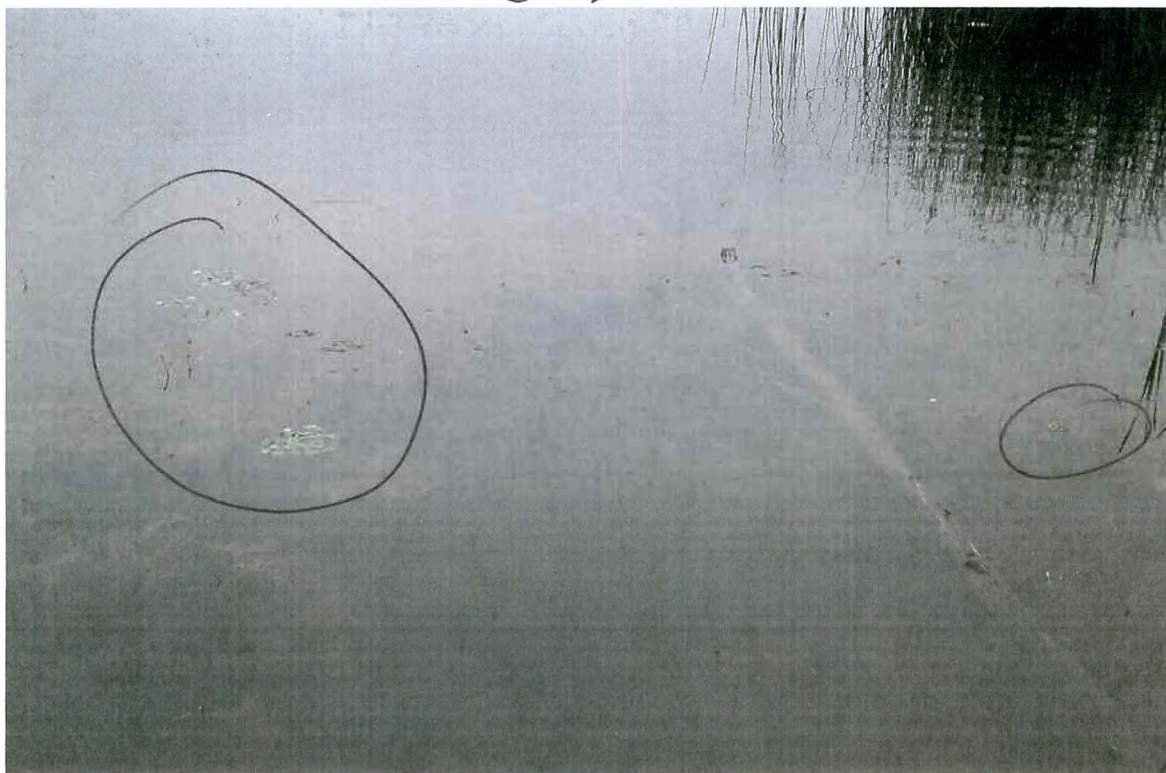
Water Chestnut

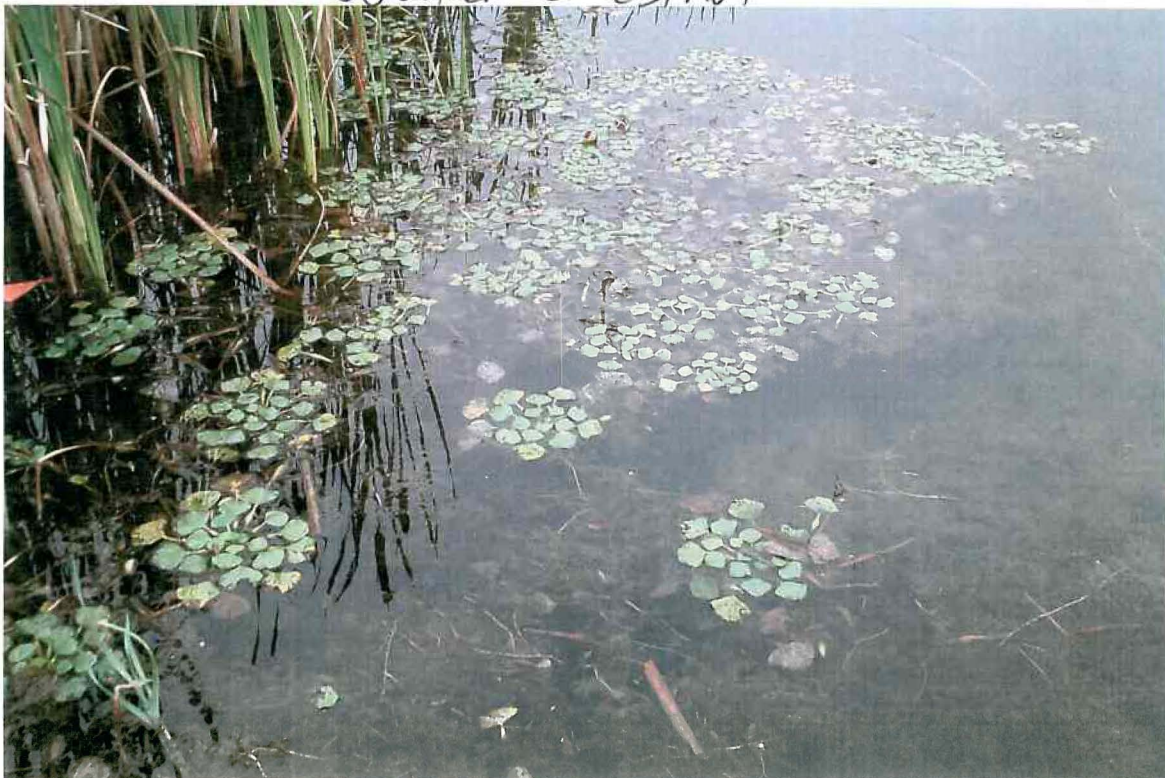
Water Chestnut

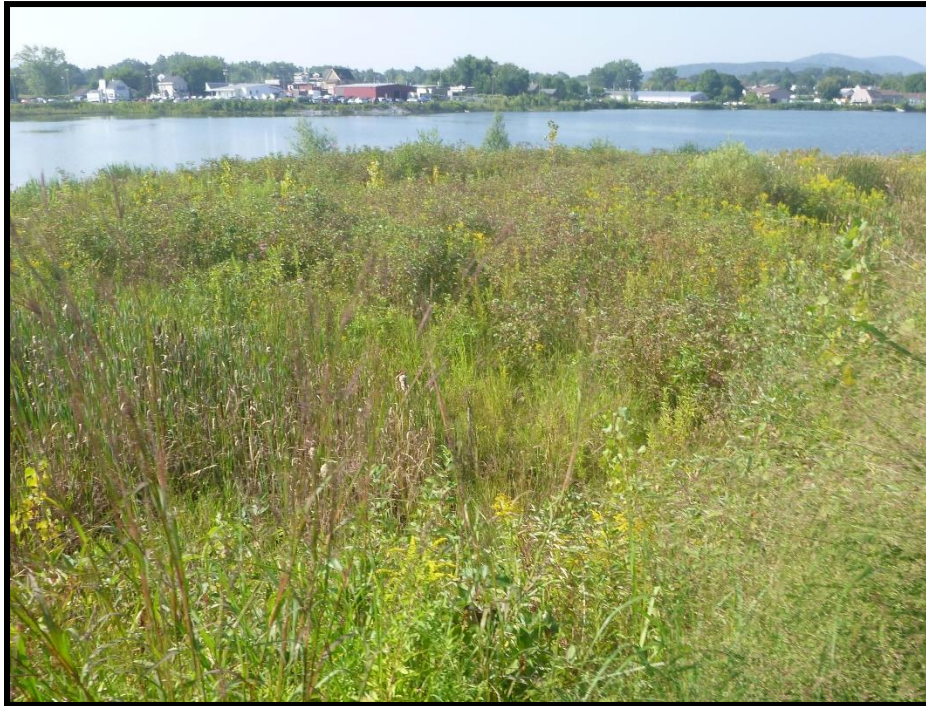
- The buttonbush on the shrub-scrub island show signs of historic stress (i.e. stunted growth), however they were observed to be in good condition during the summer 2018 inspection. Red-osier dogwoods continue to thrive on the scrub-shrub islands.

**Photograph 1: Shrub-Scrub Island**

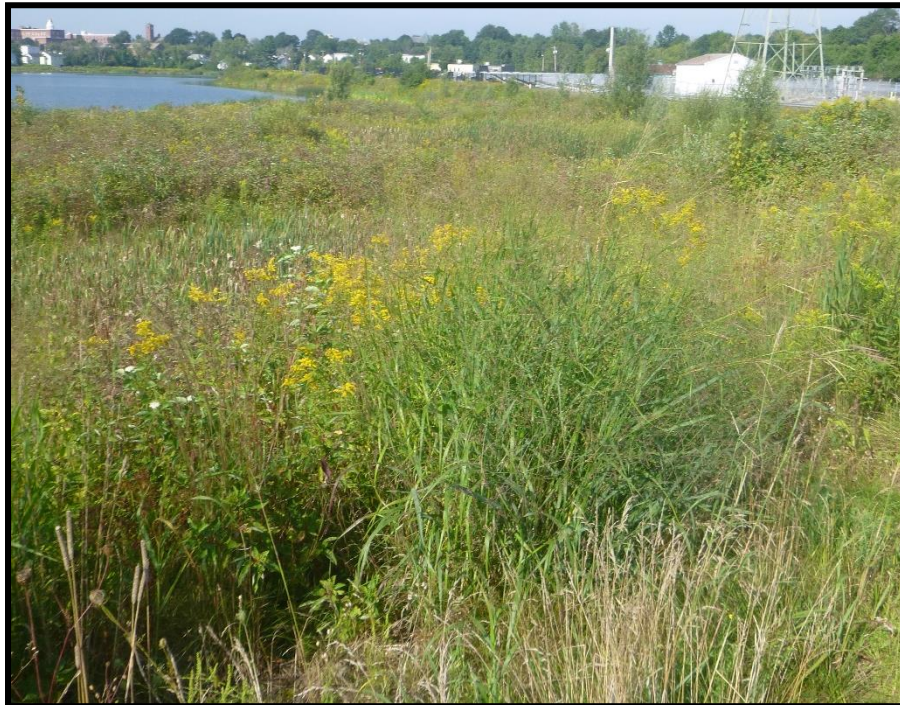
**Photograph 2: Shrub-Scrub Island**

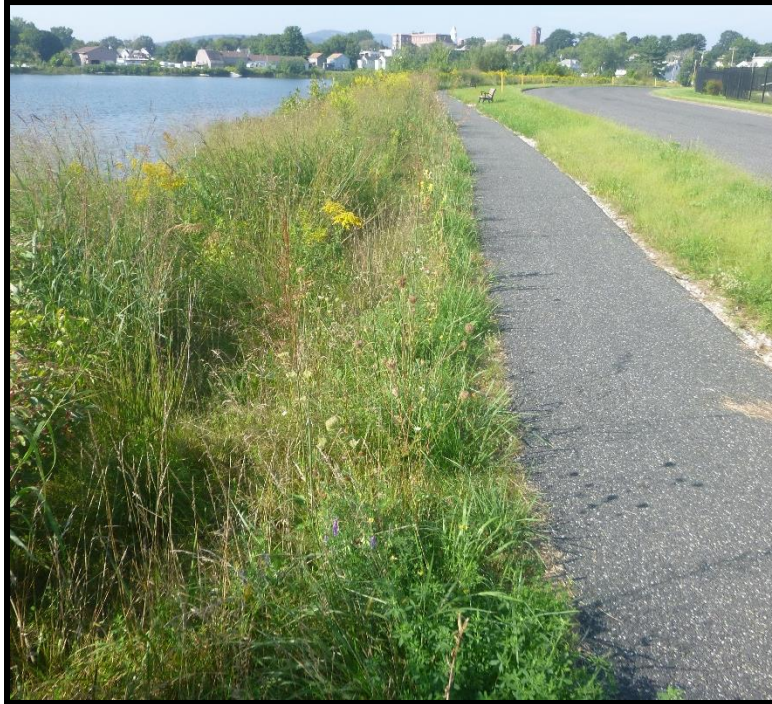
**Photograph 3: Vegetation along the north shore of Silver Lake**

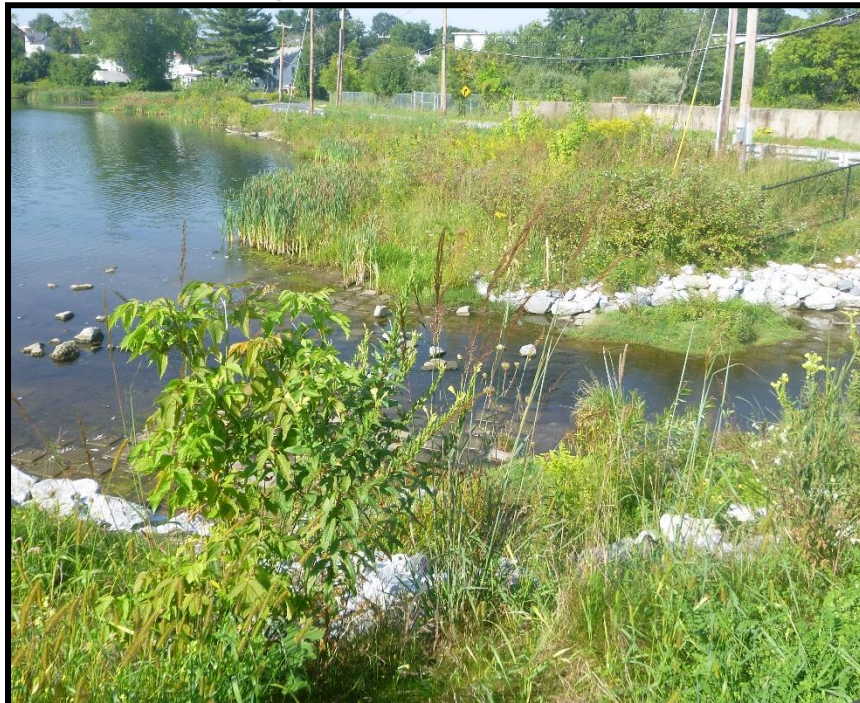
**Photograph 4: Fourth Street Outfall (looking west)**
